**GOLETA WATERSHED COMPREHENSIVE  
AND WATER CONSERVATION PLANNING P**

**GOLETA WATERSHED RI**

**JUNE 1968**

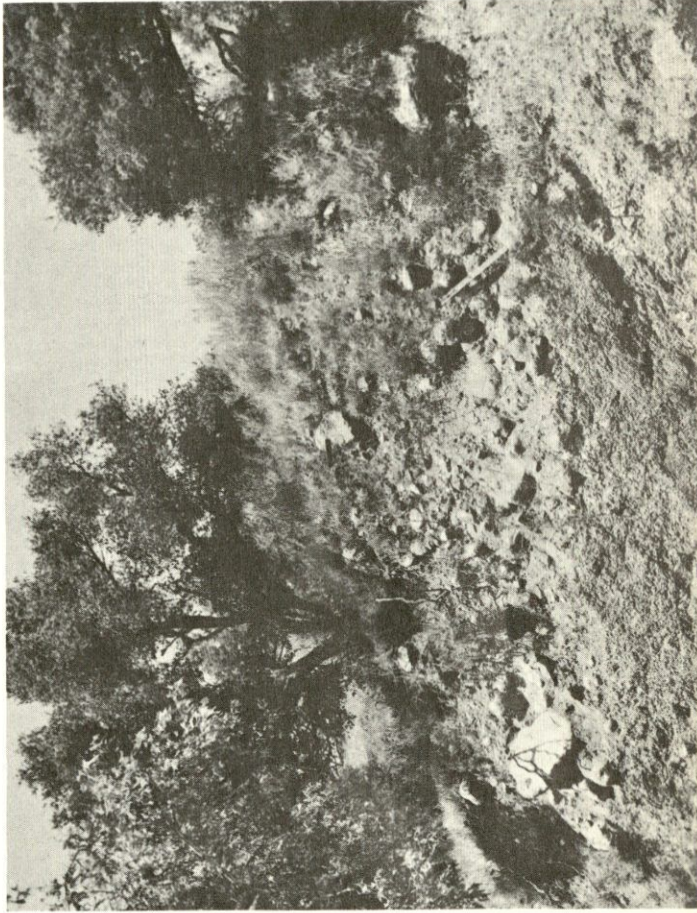
Photo 5. Unconsolidated terrace deposits unconformably overlying Rincon Shale.

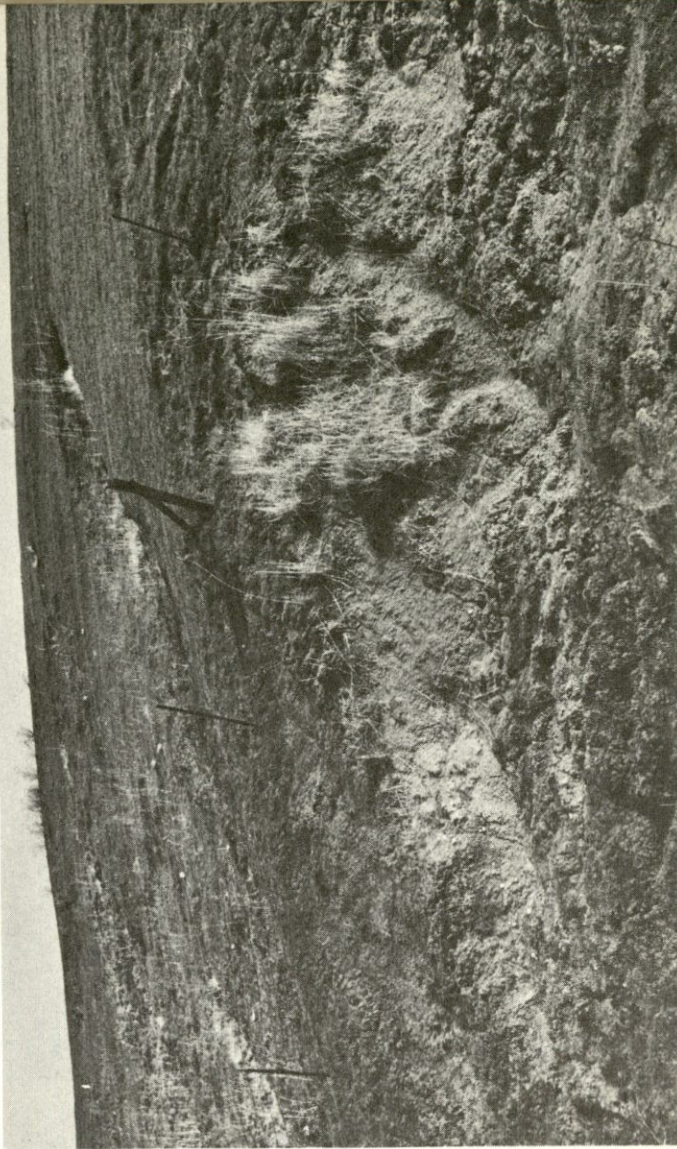
Photo 6. Soil creep on a denuded hillslope of Rincon shale.

Soil Creep, Settlement and Subsidence. The soil mantle on hillsides is subject to slow but continuous downhill movement known as creep, particularly on hillsides composed of clay. Gravity acts continuously and, even if movement is very slow, the result on structures improperly placed and constructed is inevitable failure.

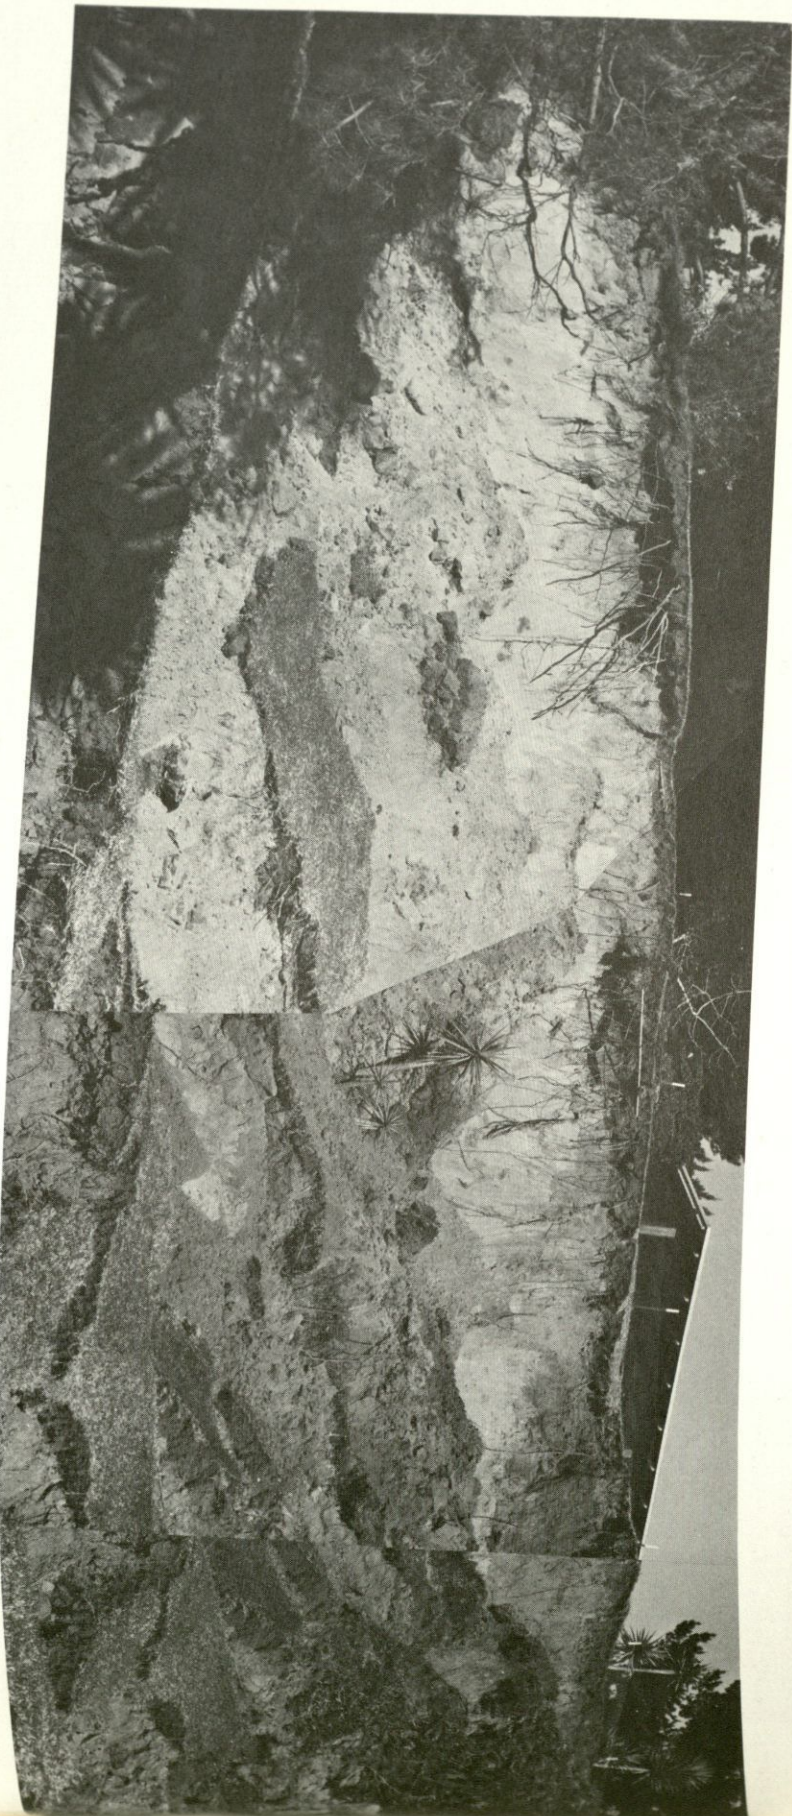
Photo 8. Portion of a landslide in marine terrace sand adjacent to high seaciff.

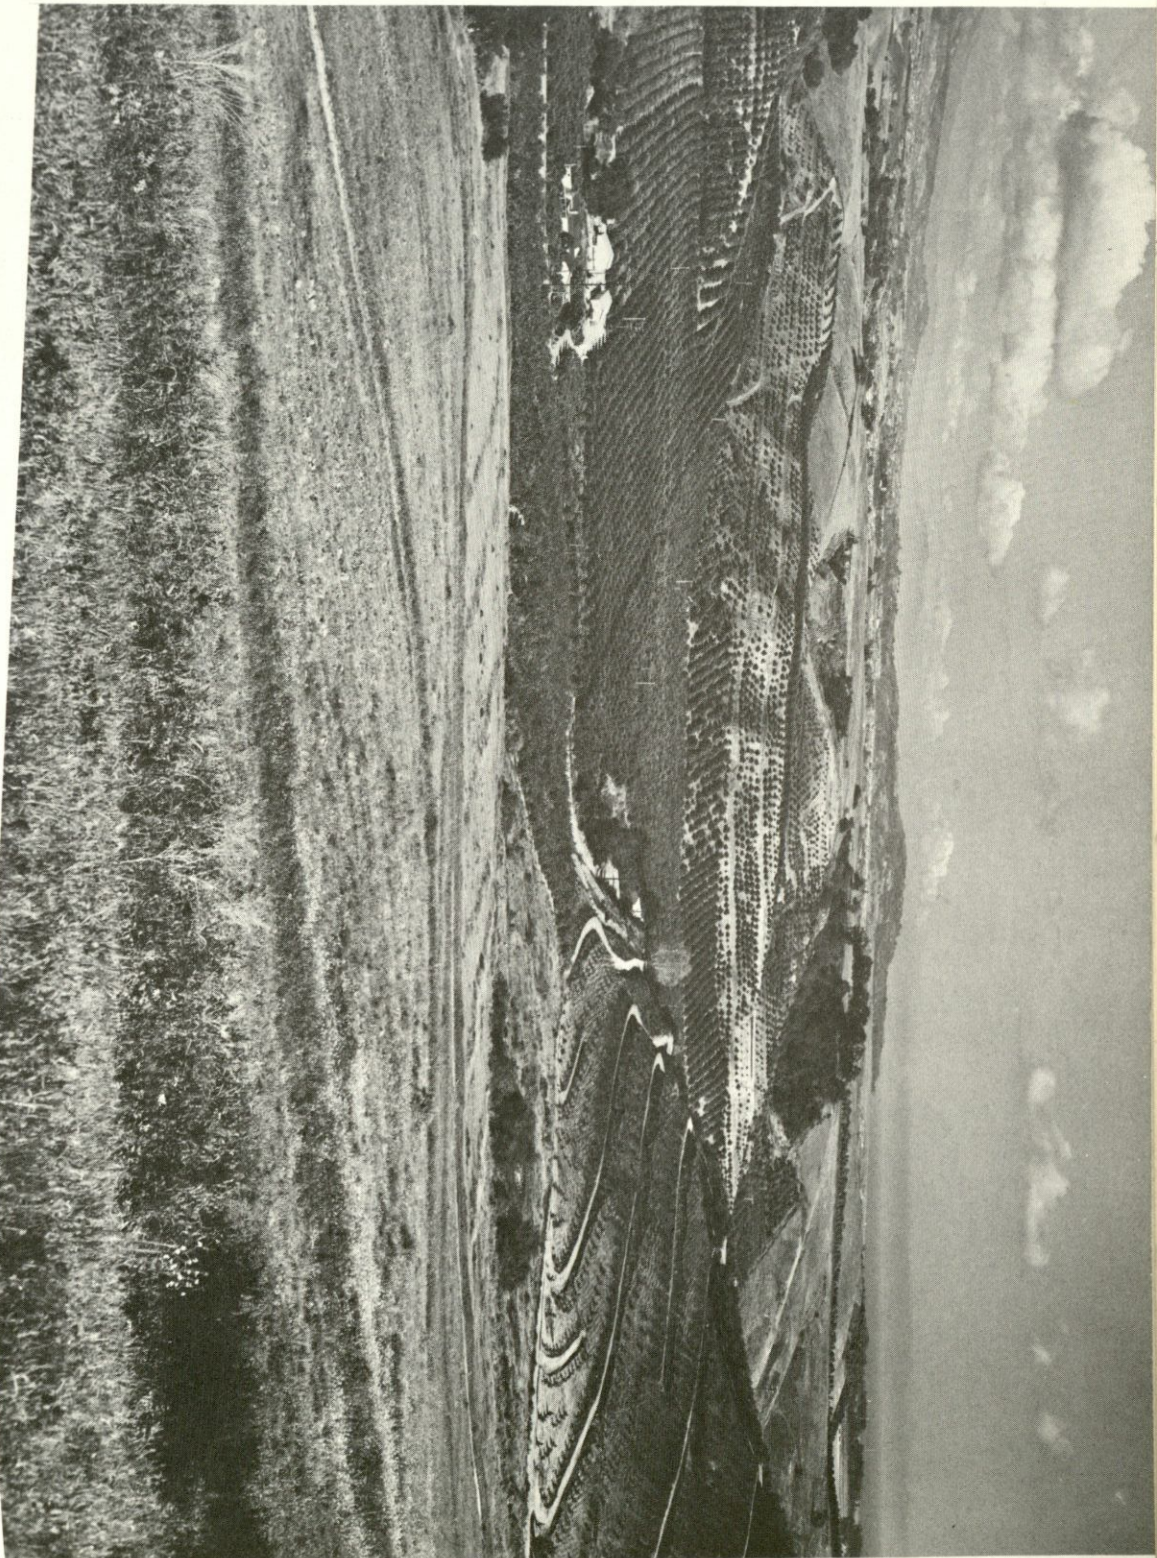
Photo 10. Agricultural development in Glen Annie Canyon. View shows various stages of developing steep eroded land for lemons and avocados. Note diversion terraces with controlled outlets. Photo by Al Robertson.

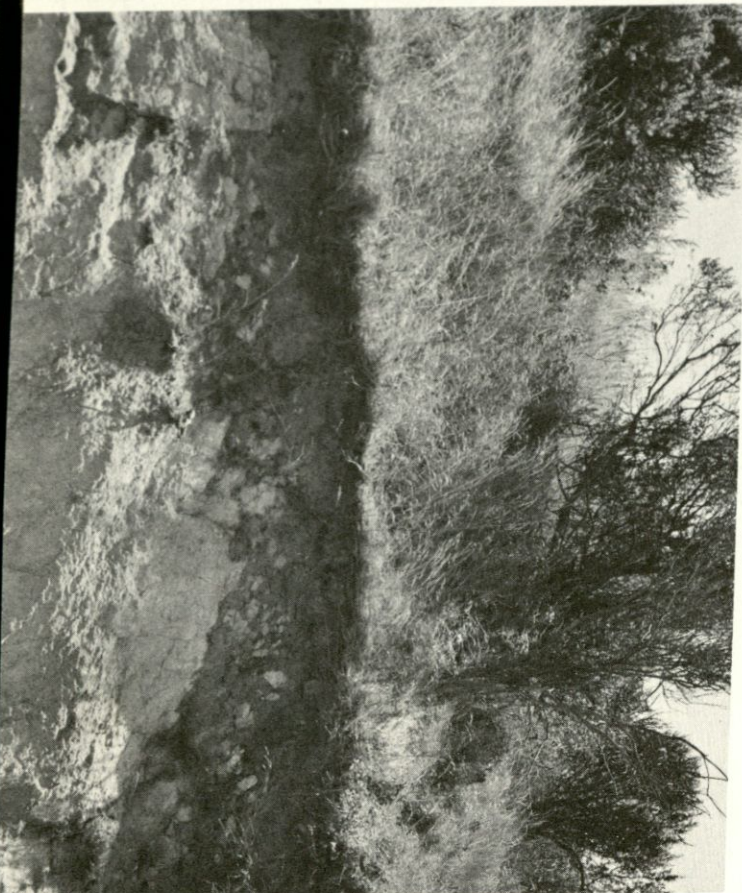
Photo 15. Residual soil. Some of these upland soils are only moderately deep to rock, soft sandstone or shale. These soils present special problems in proper use and management.

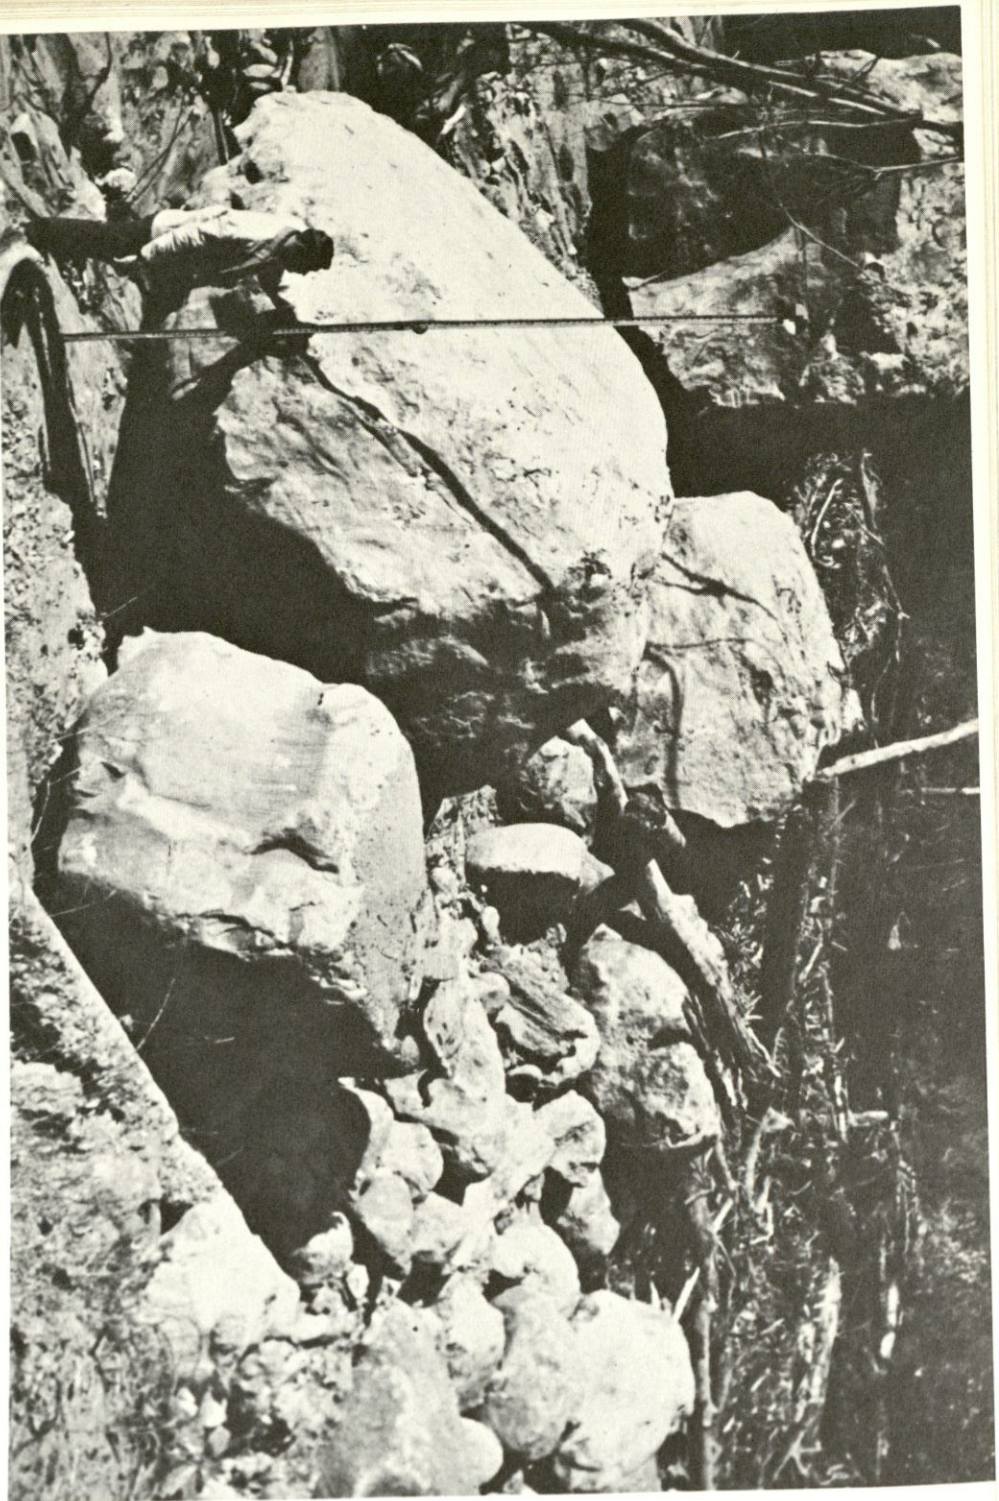
Photo 24. Debris transported by flash flood of November 9, 1964, in San Antonio Creek. The rocks in the foreground were moved about 1/4 mile and weigh up to 420 tons. The logs and tree trunks left in the background by the flood cover about 1/2 acre.

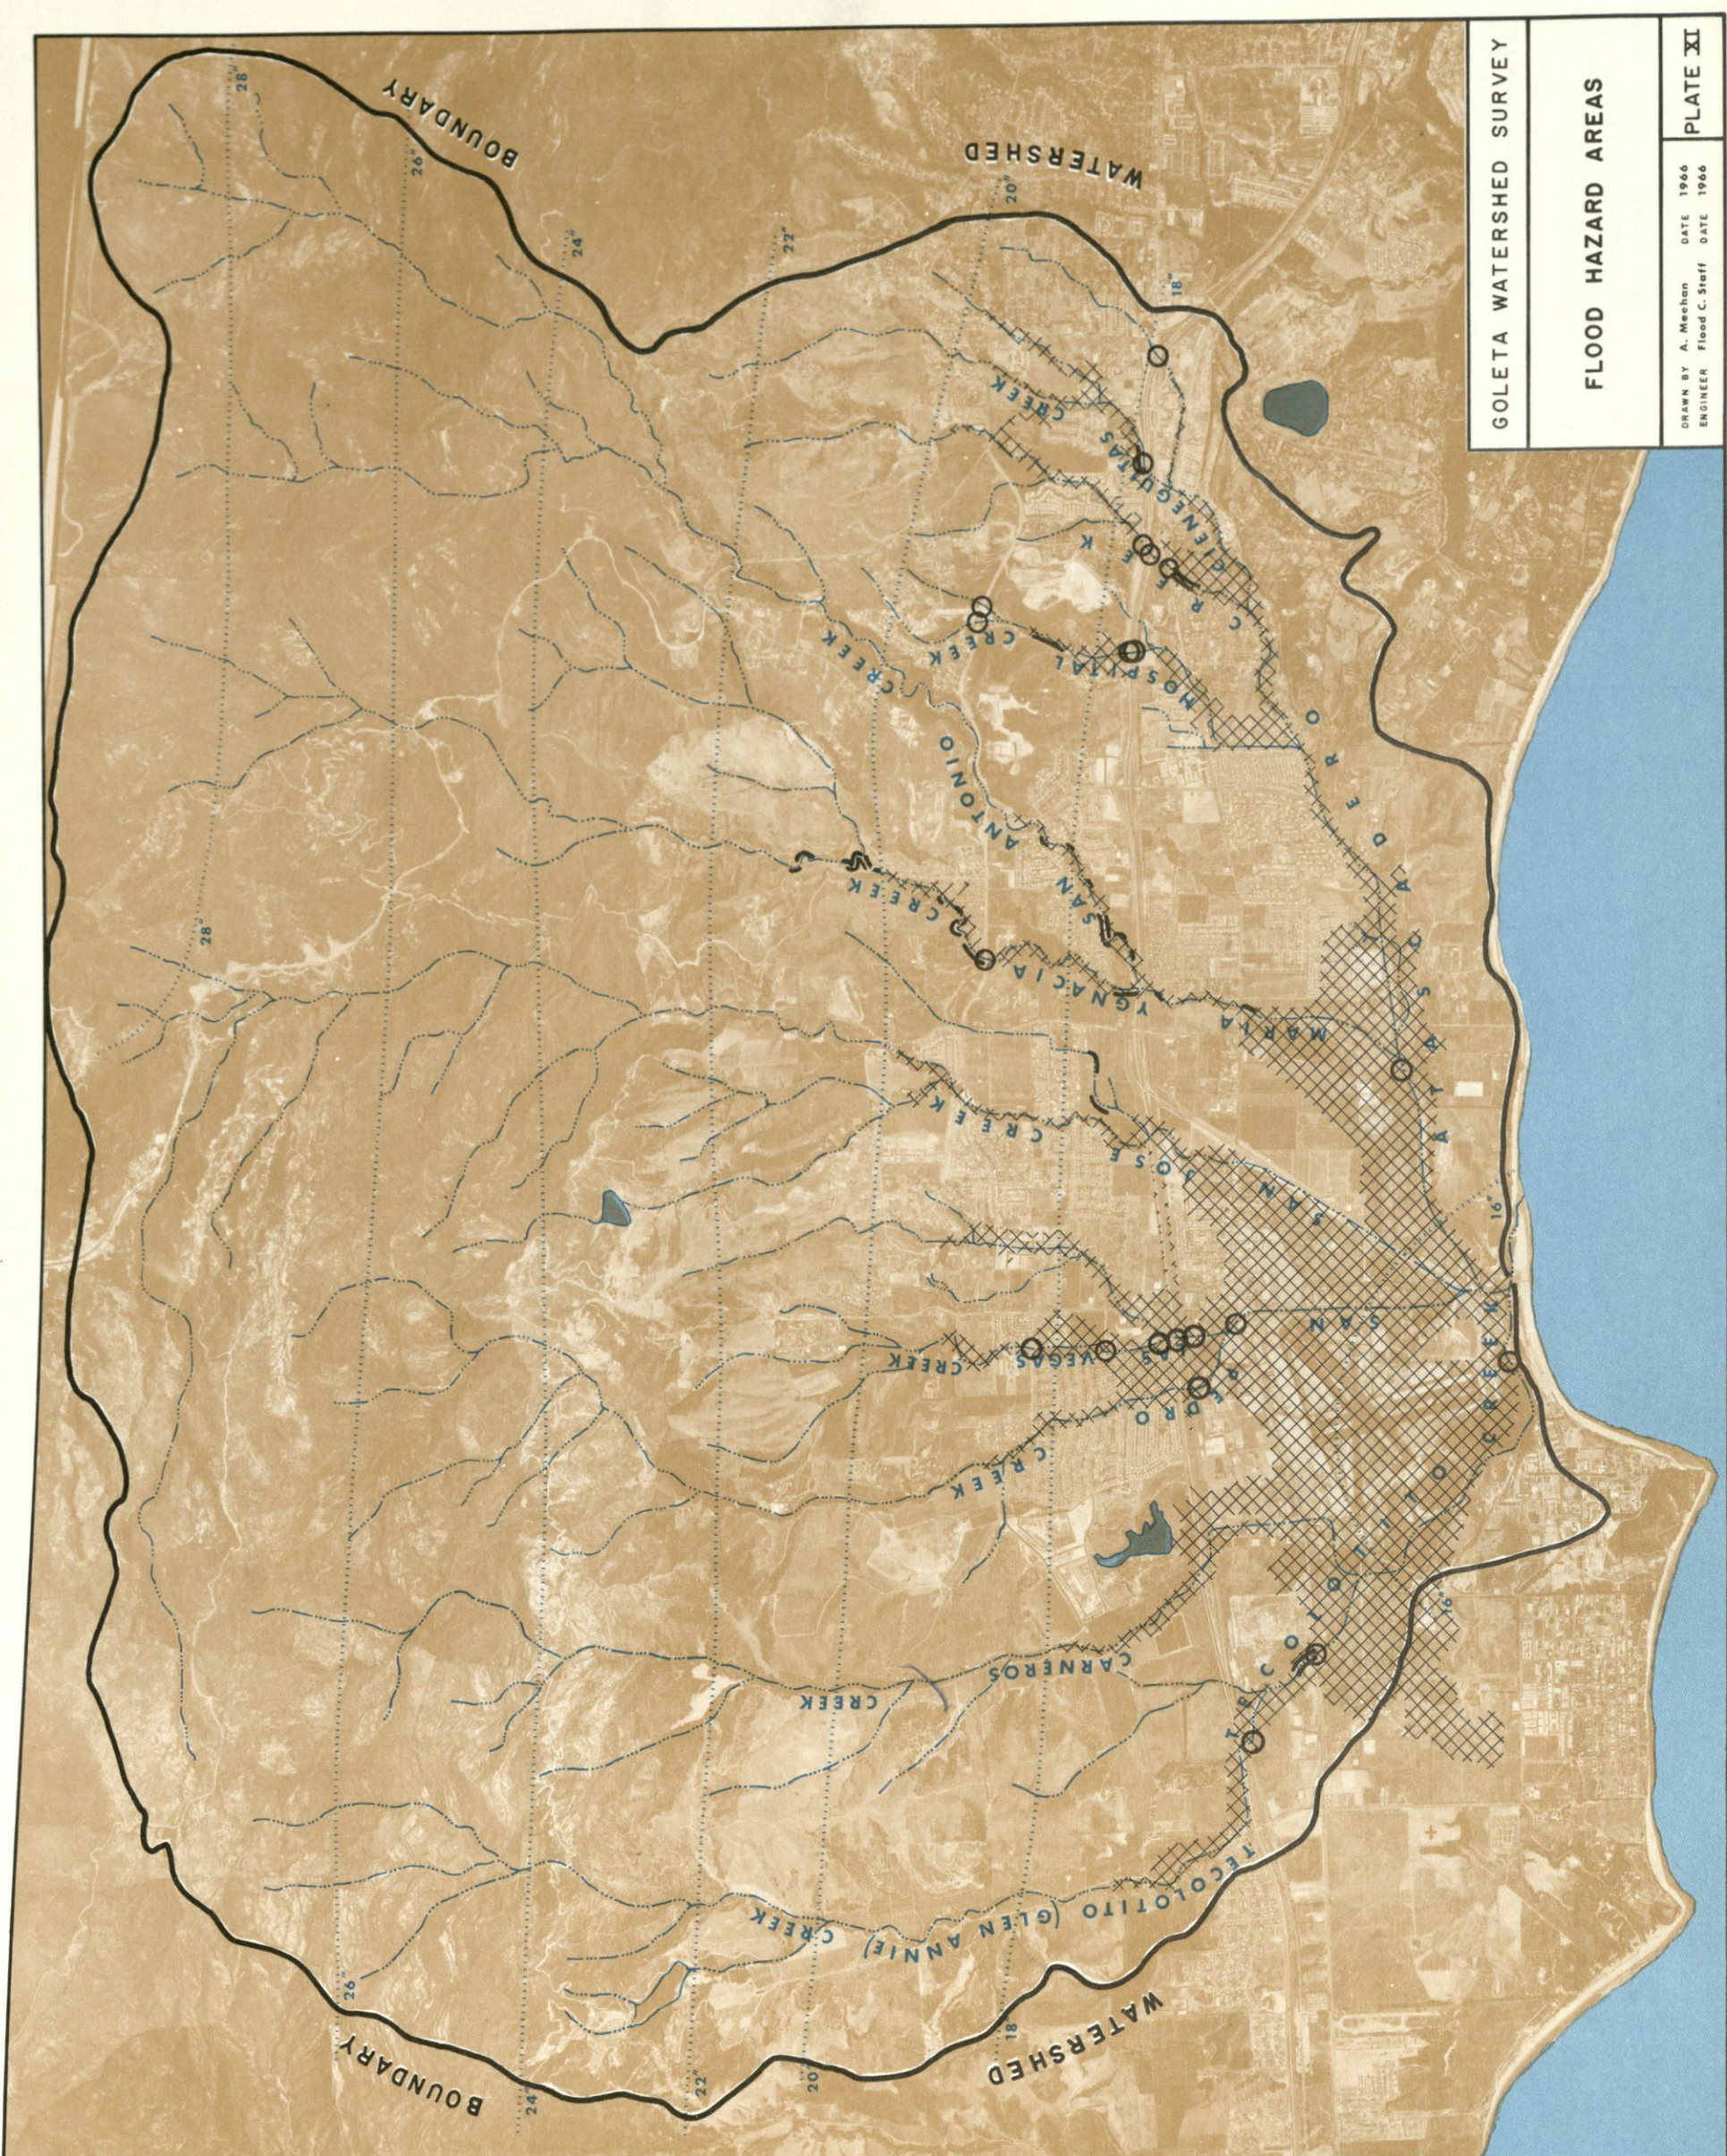
GOLETA WATERSHED SURVEY	
FLOOD HAZARD AREAS	
DRAWN BY A. Meehan	DATE 1966
ENGINEER Flood C. Steff	DATE 1966
PLATE XI
